**GROUP CHAIRMAN'S FACTUAL
REPORT OF INVESTIGATION
SOUND SPECTRUM STUDY**

Sound Spectrum Study

DCA-96-MA-070

Location: East Moriches, New York
Date: July 17, 1996
Time: 2031:12 Eastern Daylight Time
Aircraft: Trans World Airlines Inc.
Boeing 747-131 N93119

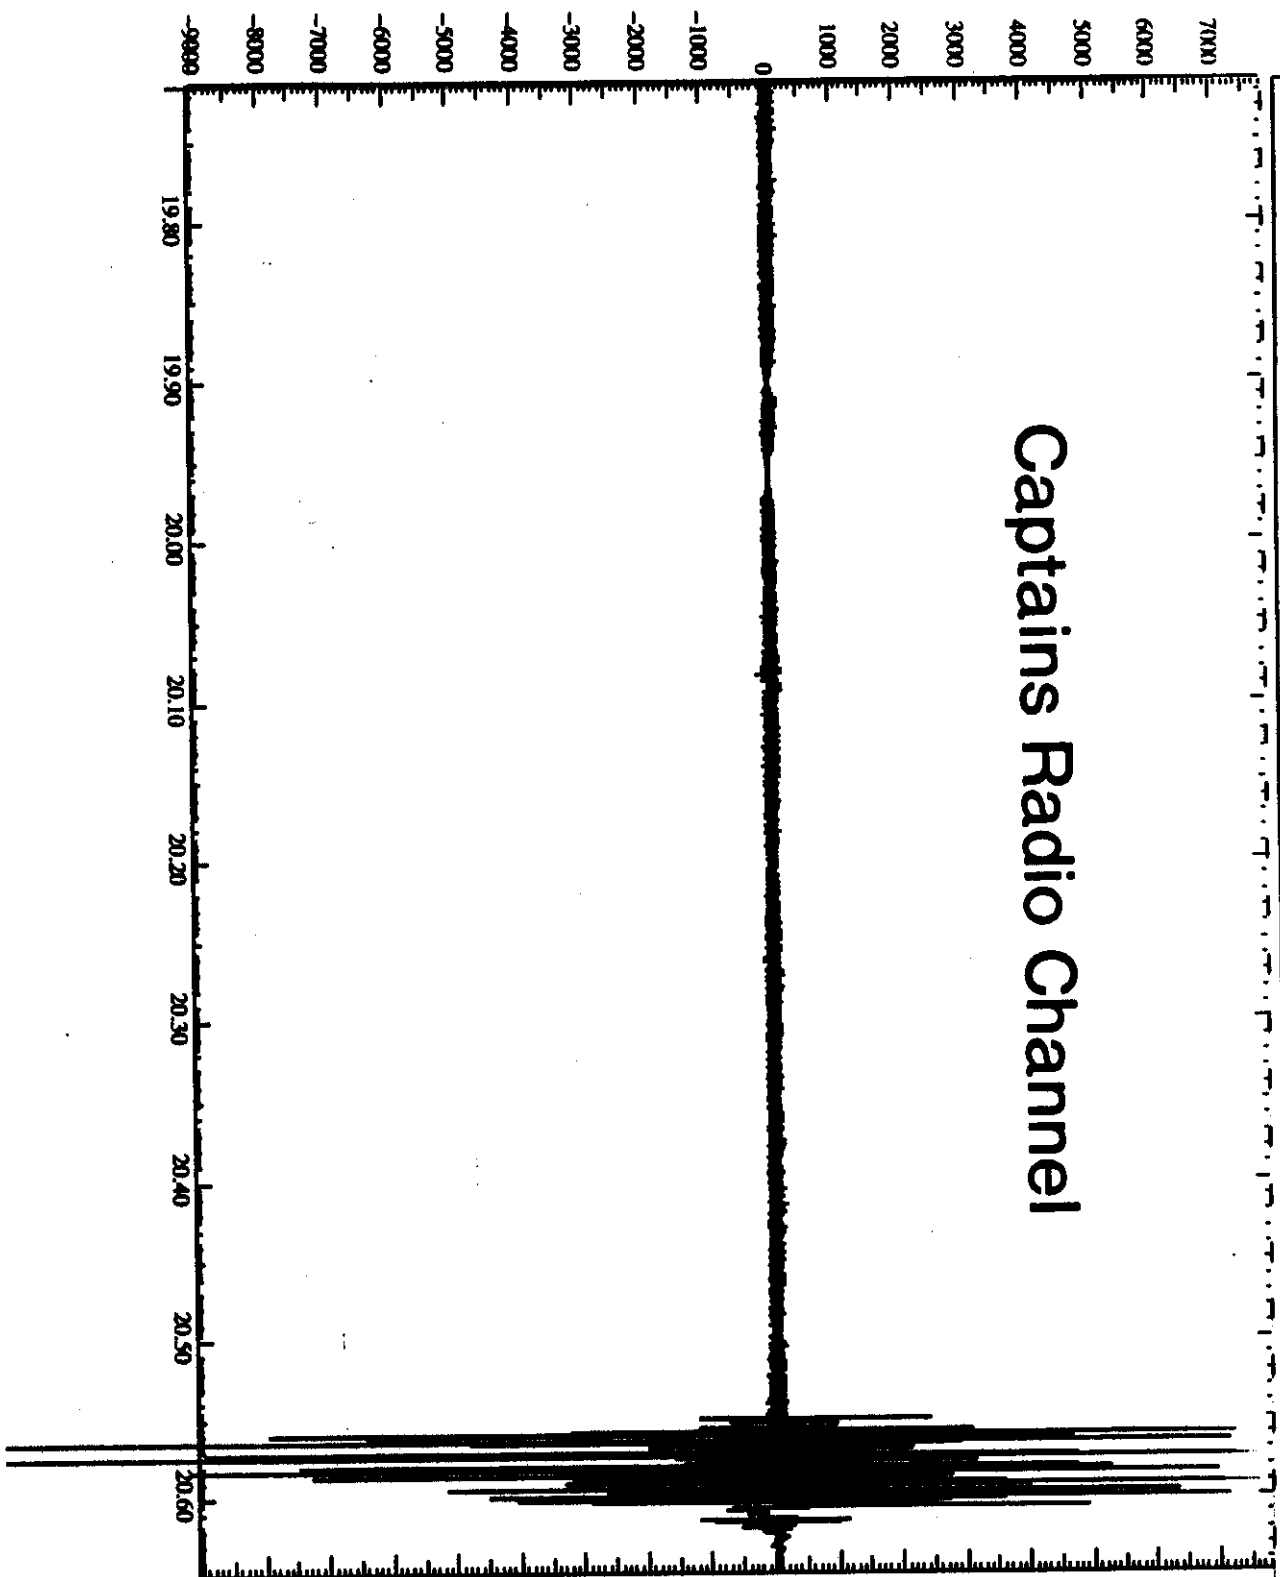
At time 0.73 seconds before the end of the recording and again at 0.68 seconds before the end, the normal 400 Hz signal with its associated harmonics changed. Chart 1 depicts this change in the background signal as observed on the Captain's radio channel. This change consists primarily of a lack of the upper harmonics of the 400 Hz. During these two different areas the signal contains only the 400 Hz component, no added harmonics. Chart 2 depicts the Captain's radio channel and the frequency plots for the regions prior, during and after the disturbance. Chart 3 depicts all of the 3 radio channels in this same area. It can be seen that the disturbance is identifiable only on the Captain's radio track of the CVR.

only nominal background noise. This background noise consisted primarily of the 400 Hz. aircraft electrical system power "hum". In addition to this predominant 400 Hz. frequency there was additional signals consisting of the 2nd (800 Hz.) and 3rd (1200 Hz.) harmonic tones of the primary 400 Hz.

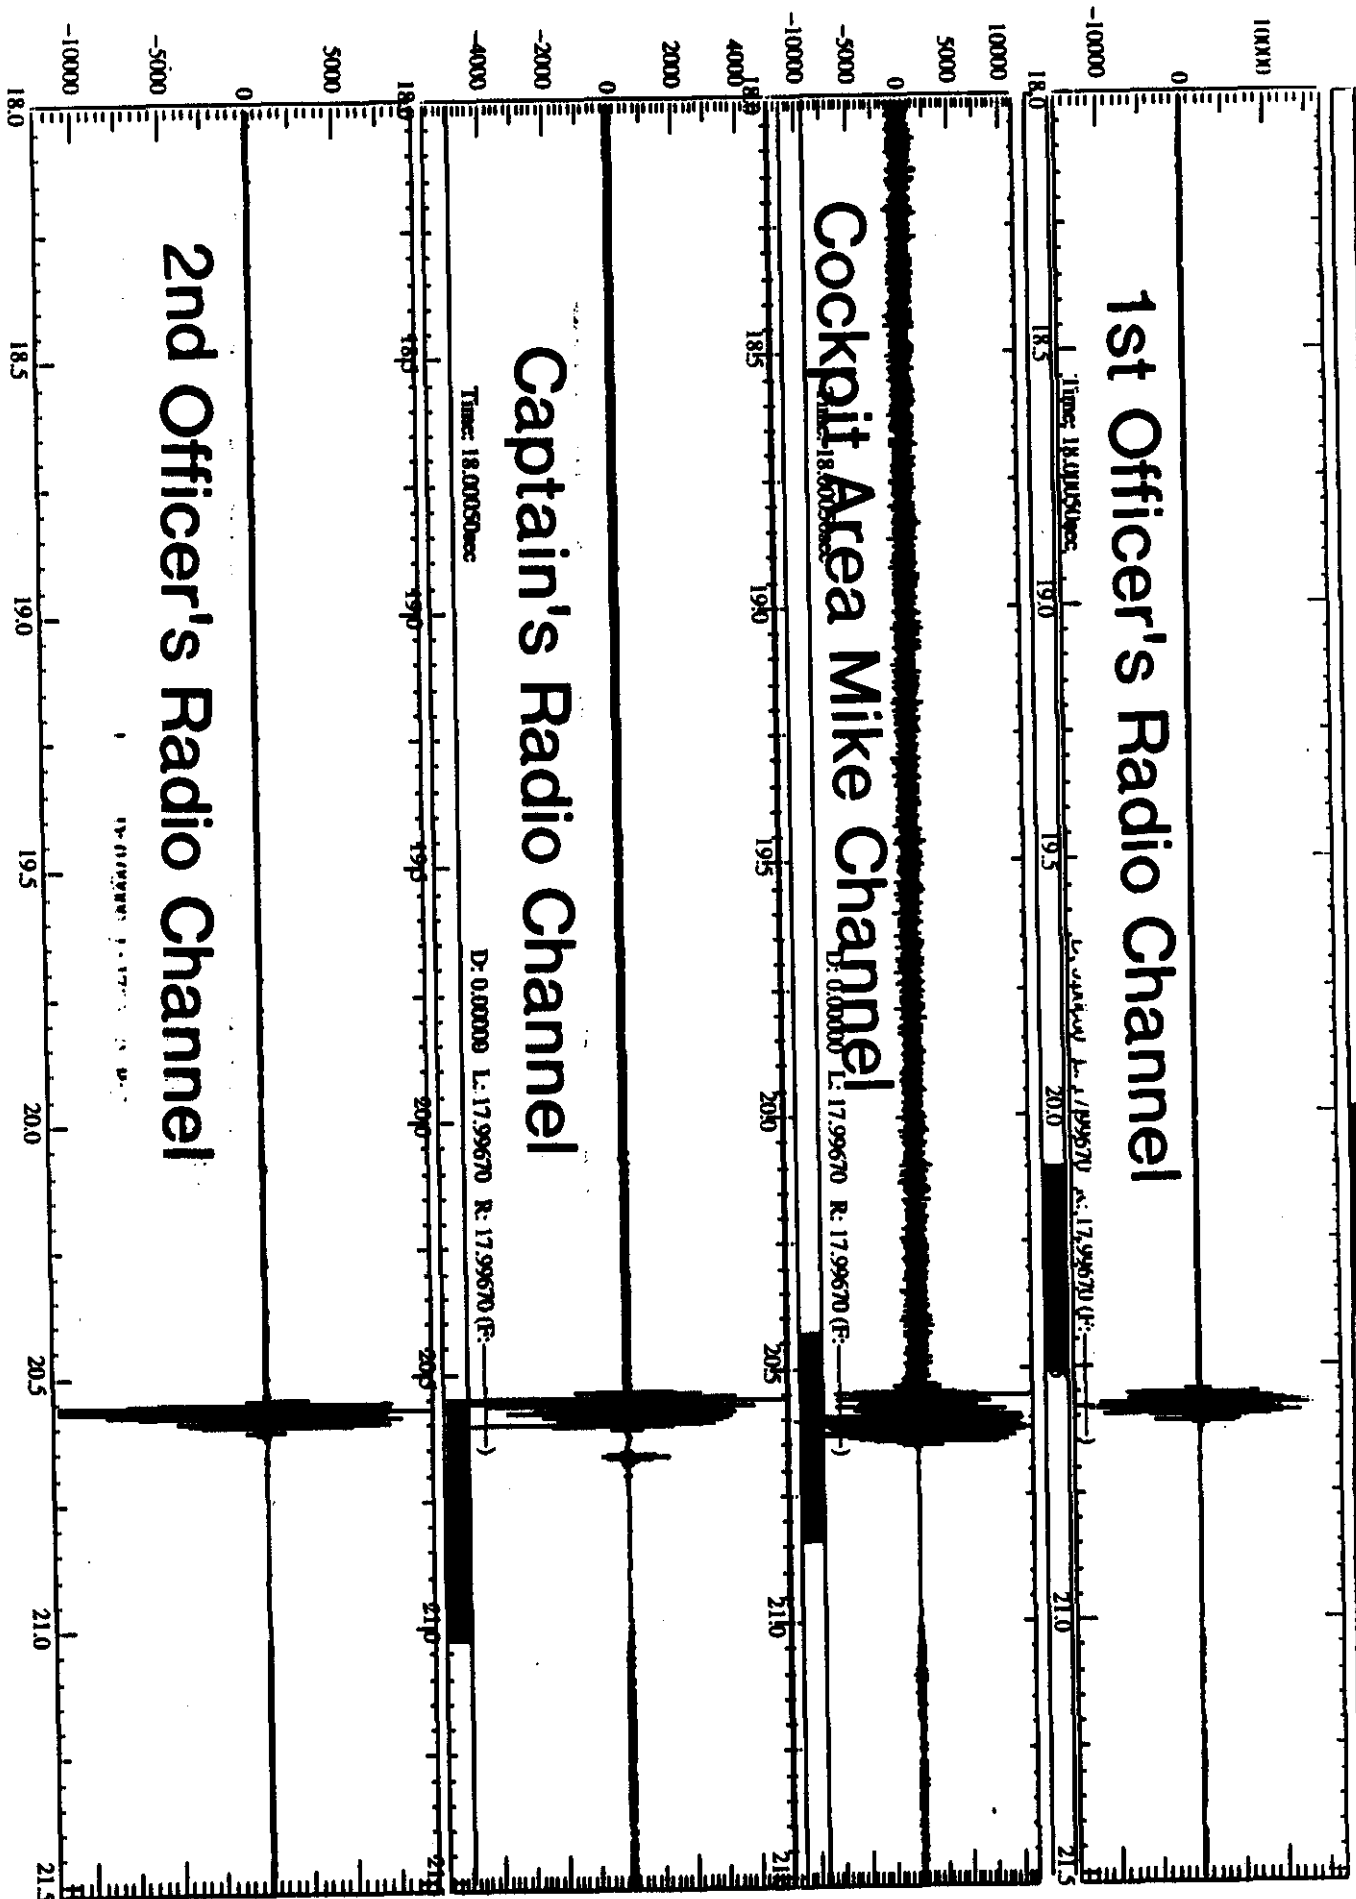
The CVR recording was for the most part very routine and normal until it abruptly ended. This sudden termination of the recording affected all 4 of the CVR channels. Chart 4 depicts the 4 CVR channels for about the last second of CVR data. The top trace displays the data from the 1st Officers radio/intercom channel. The 2nd trace is the data from cockpit area microphone channel. The 3rd trace is the data from the Captain's radio/intercom channel. The 4th trace depicts the information from the 2nd Officer's radio/intercom channel.

It can be seen from chart 4 that the termination of the recording affected all of the channels slightly differently. It could be assumed that the termination event should look the same on the 3 radio channels. These 3 channels all are identical in their function and they are all being fed information obtained from identical sources. It can be seen on the chart that trace 3 (Captain's radio) is affected 7.25 microseconds

before any disturbance is observed on the other radio channels.

In Charts 8,9,10,11 and in the accident chart (4) it can be seen that in all of flights not only is the disturbance observed on the cockpit area microphone (CAM) channel but a similar disturbance is also observed on all of the radio channels. These disturbance patterns were examined in an attempt to associate the accident flight's CVR signatures with a previous recording.

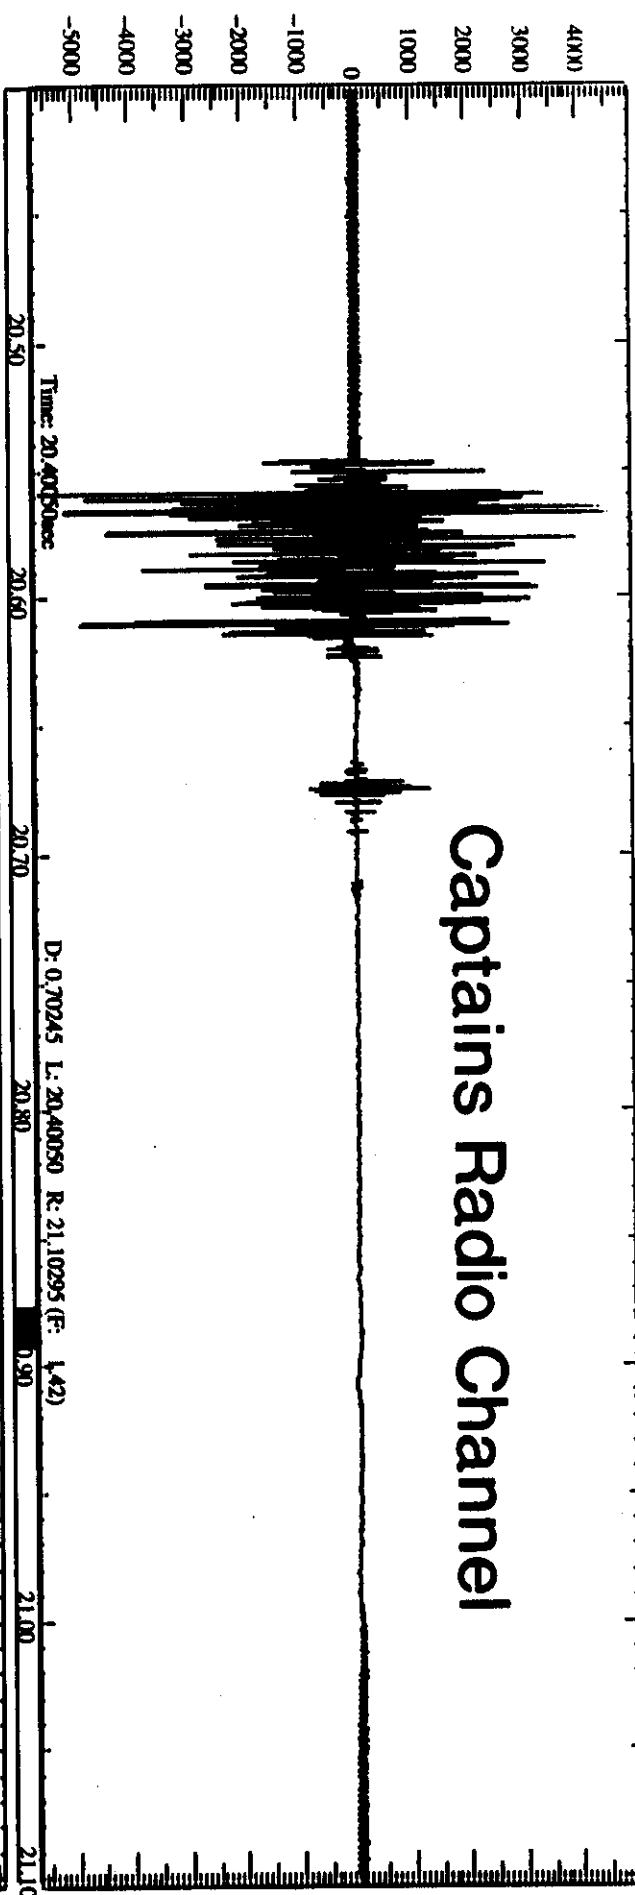
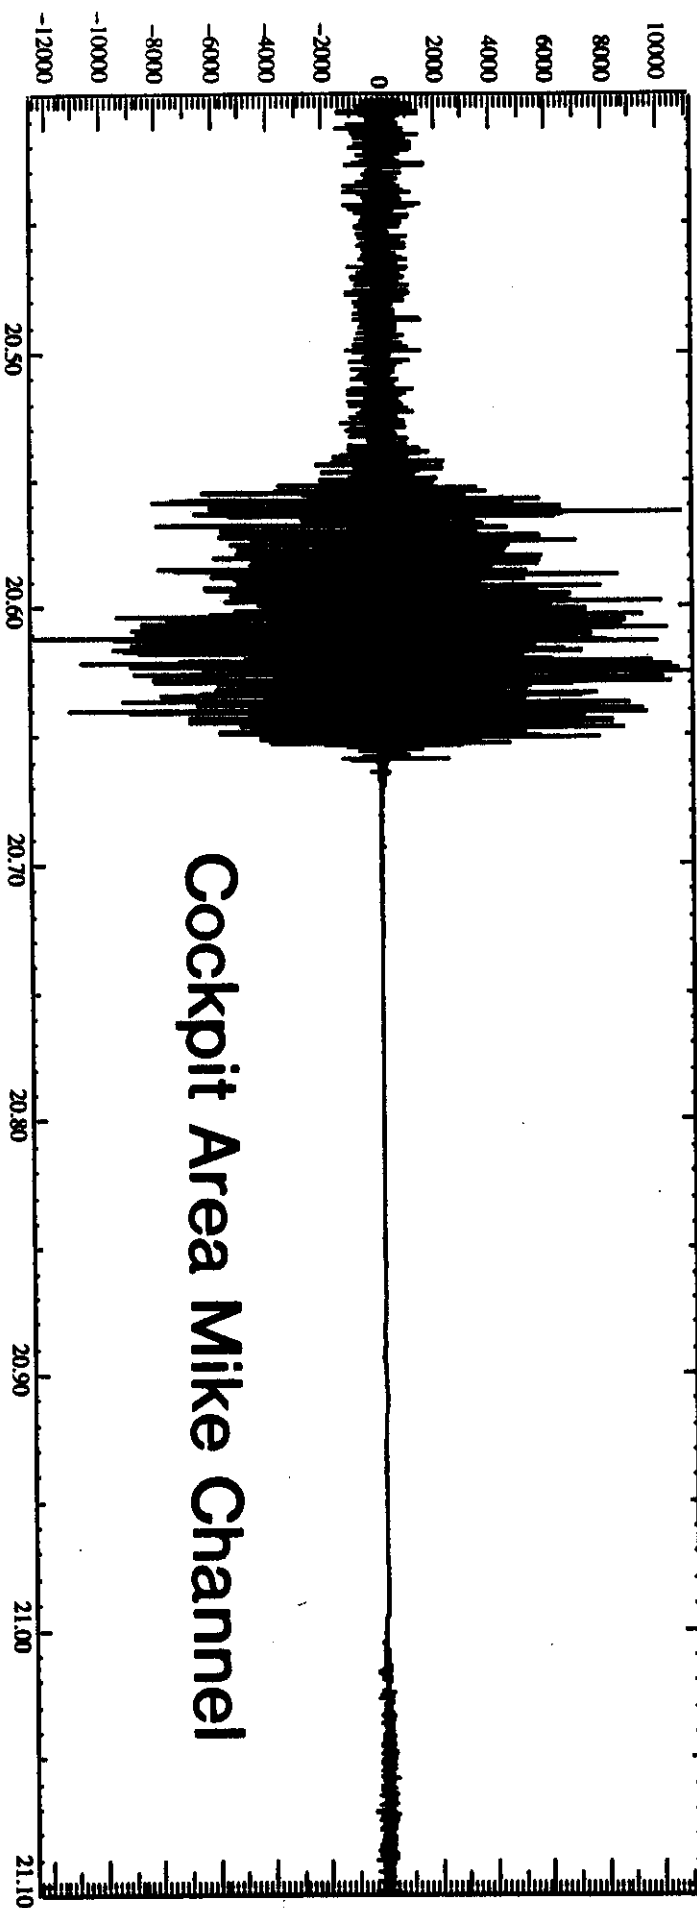
Charts 5,6,and 7 show in greater detail the relationships between the various radio channels and the corresponding area microphone channel. Chart 5 is the 1st Officers radio on the top and the area microphone channel below it. Chart 6 depicts the Captain's radio and area mike information and chart 7 depicts the 2nd Officers and area mike information.

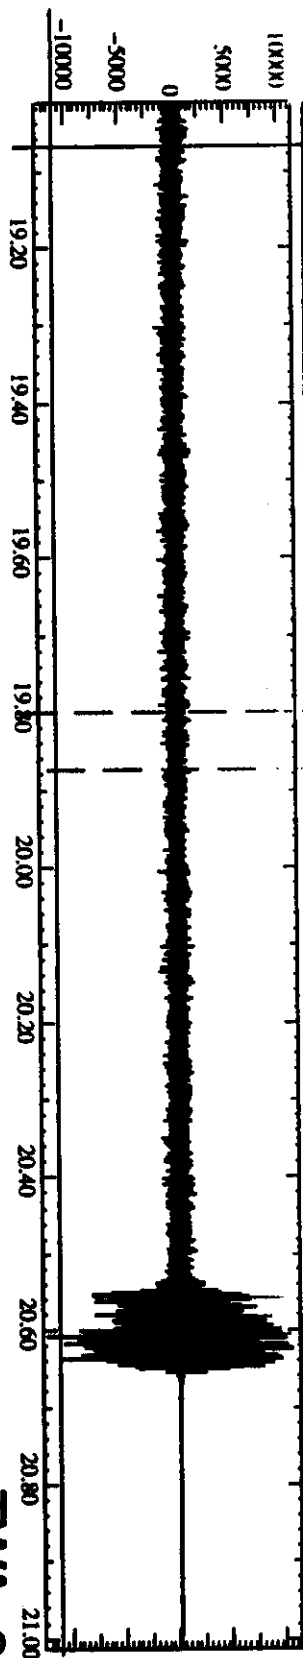
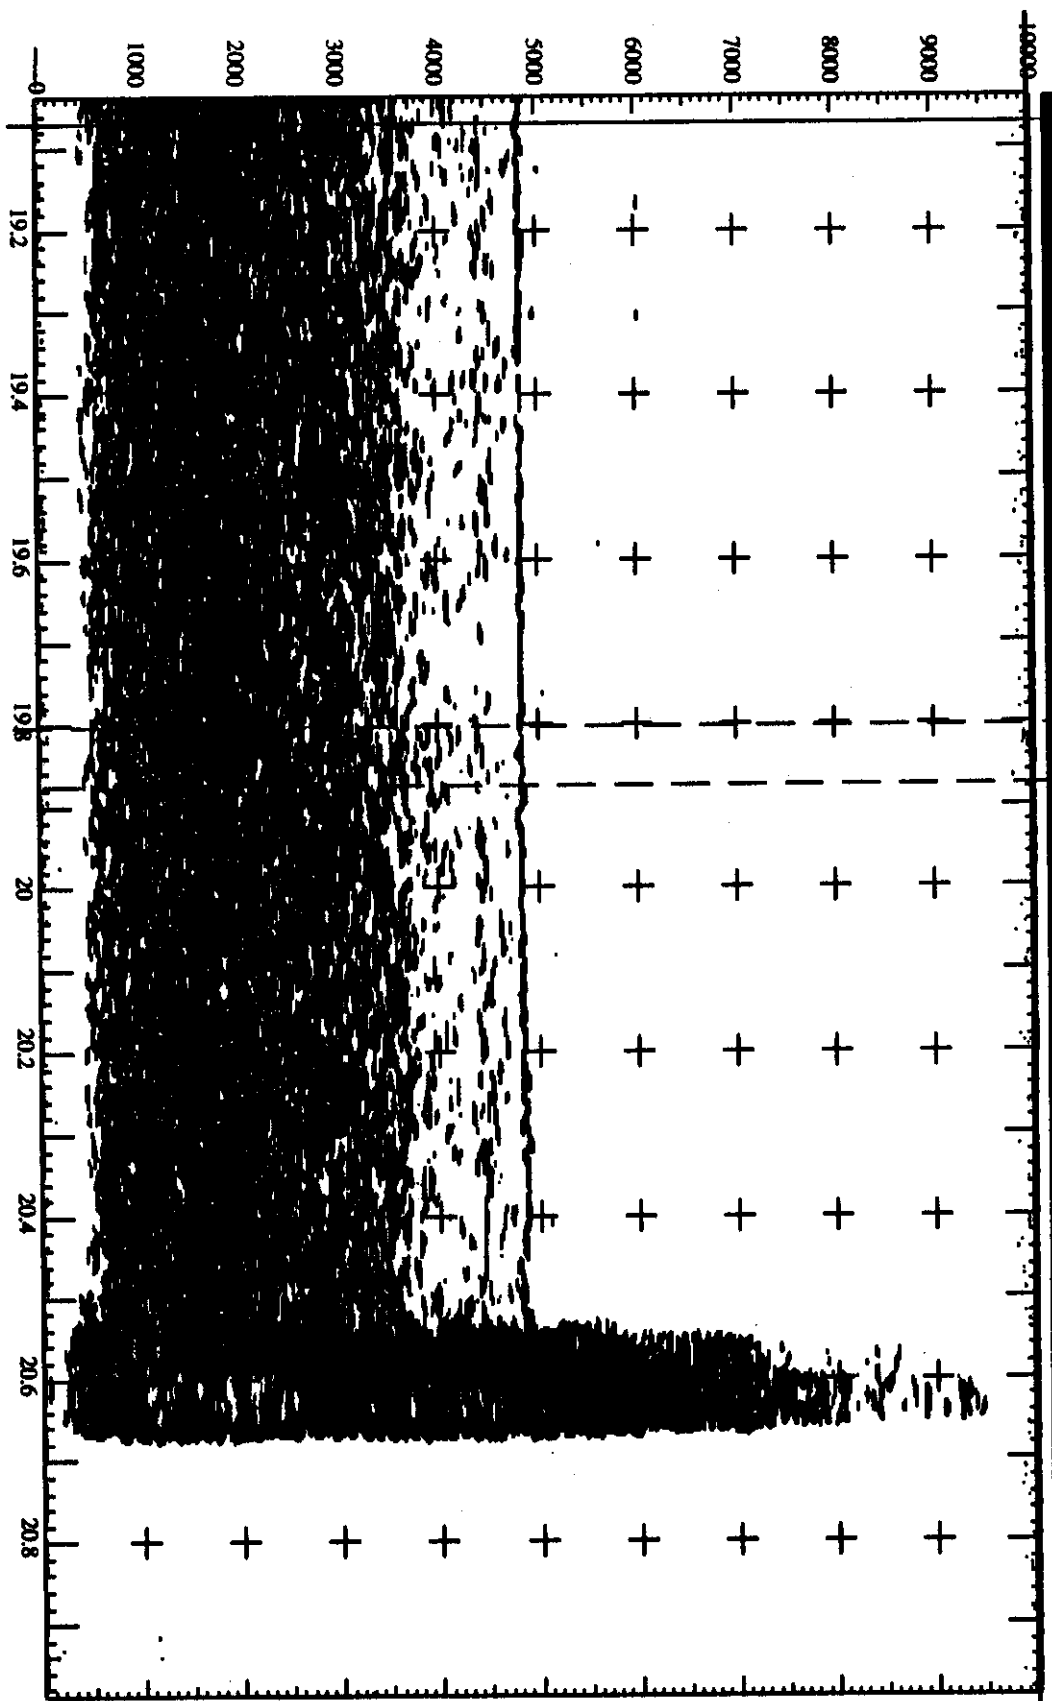
Chart 12 depicts the waveform amplitude signatures of the various comparison accidents along with the TWA-800 accident recording. This chart depicts the various waveform amplitudes vs. time. It should be noted that the absolute amplitude of the various recordings is unknown. Care should be used when attempting to compare waveform characteristics based only on the amplitude.

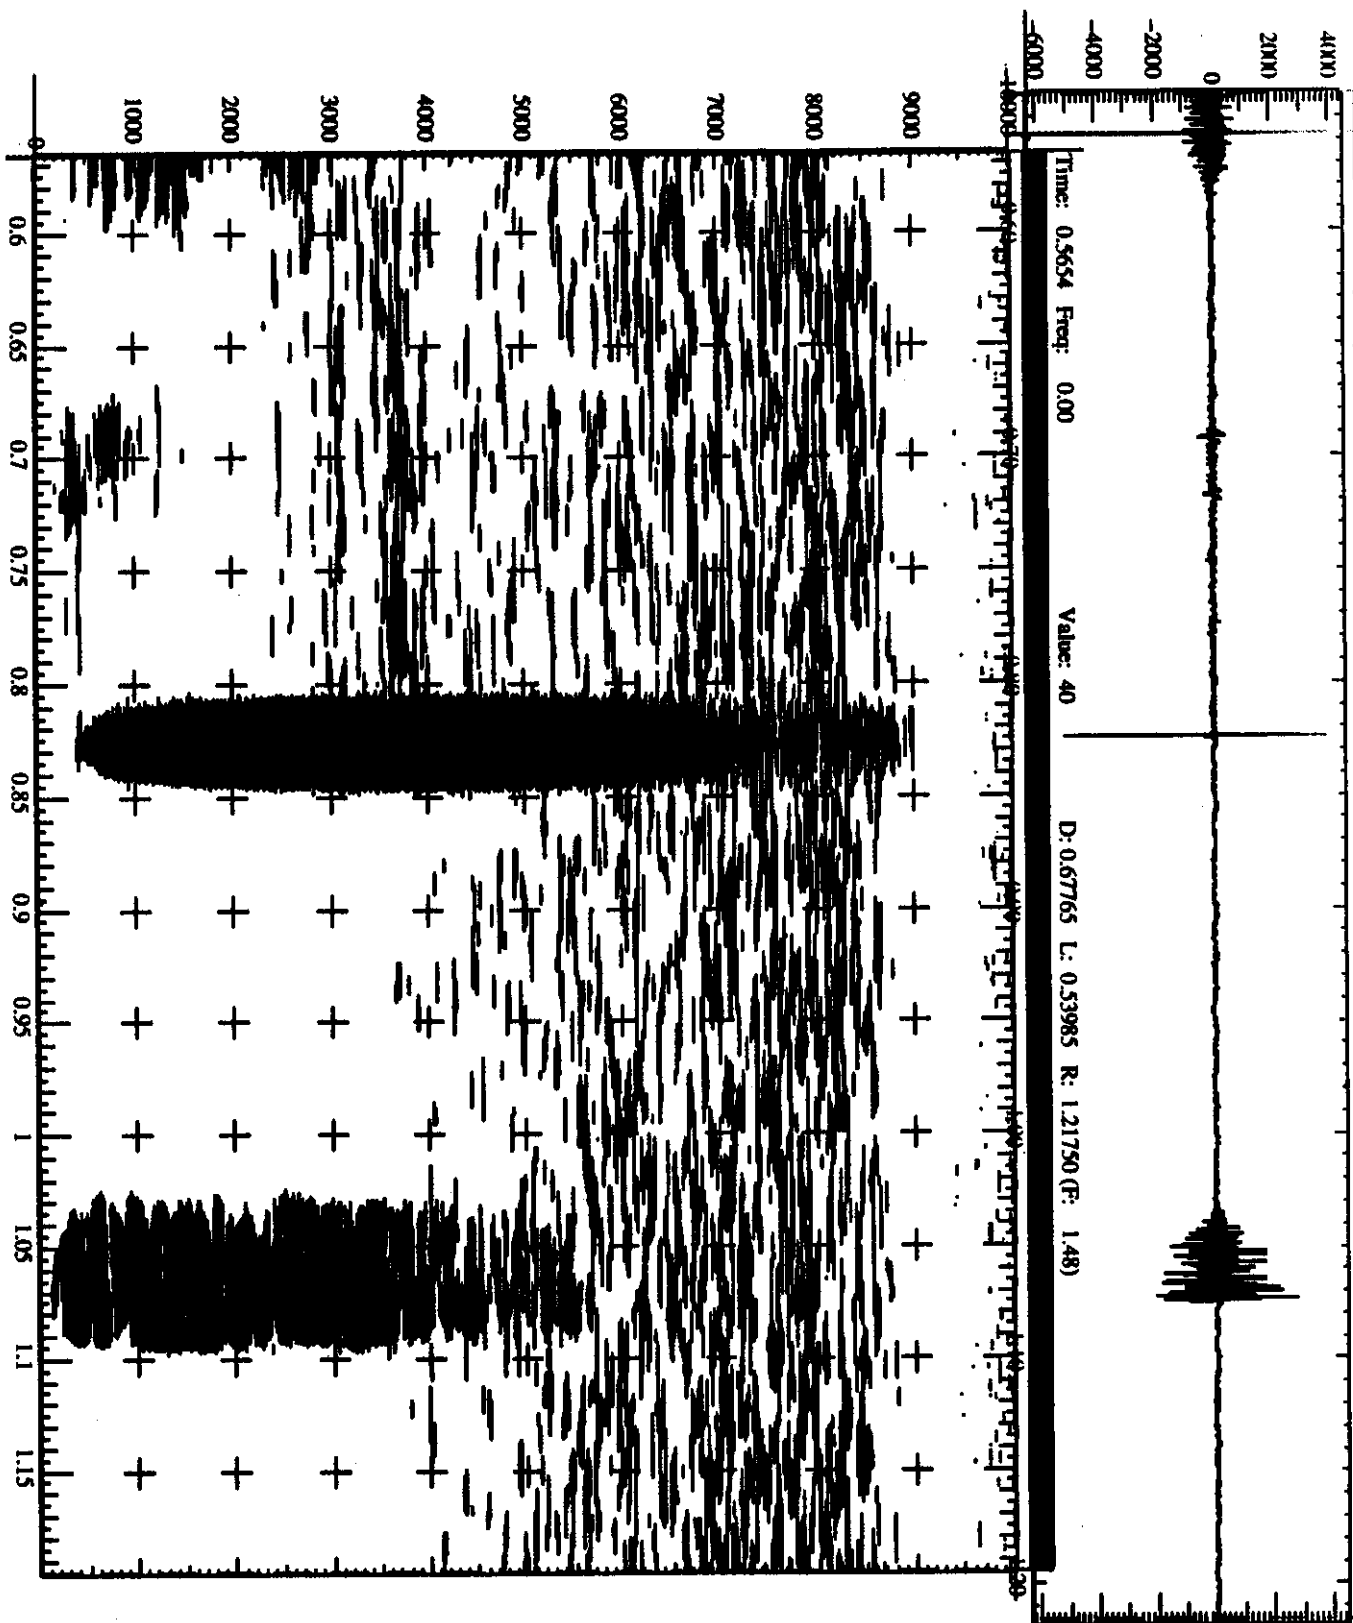
Chart 17

Charts 13,14,15,16 and 17 depict the area mike recordings and their associated frequency spectrum signatures. In these charts the top trace is the analog waveform plot and the bottom trace is a 3-dimensional frequency spectrum plot. This type of chart presents frequency along the vertical axis, time along the horizontal and spectral intensity or energy in the color information.

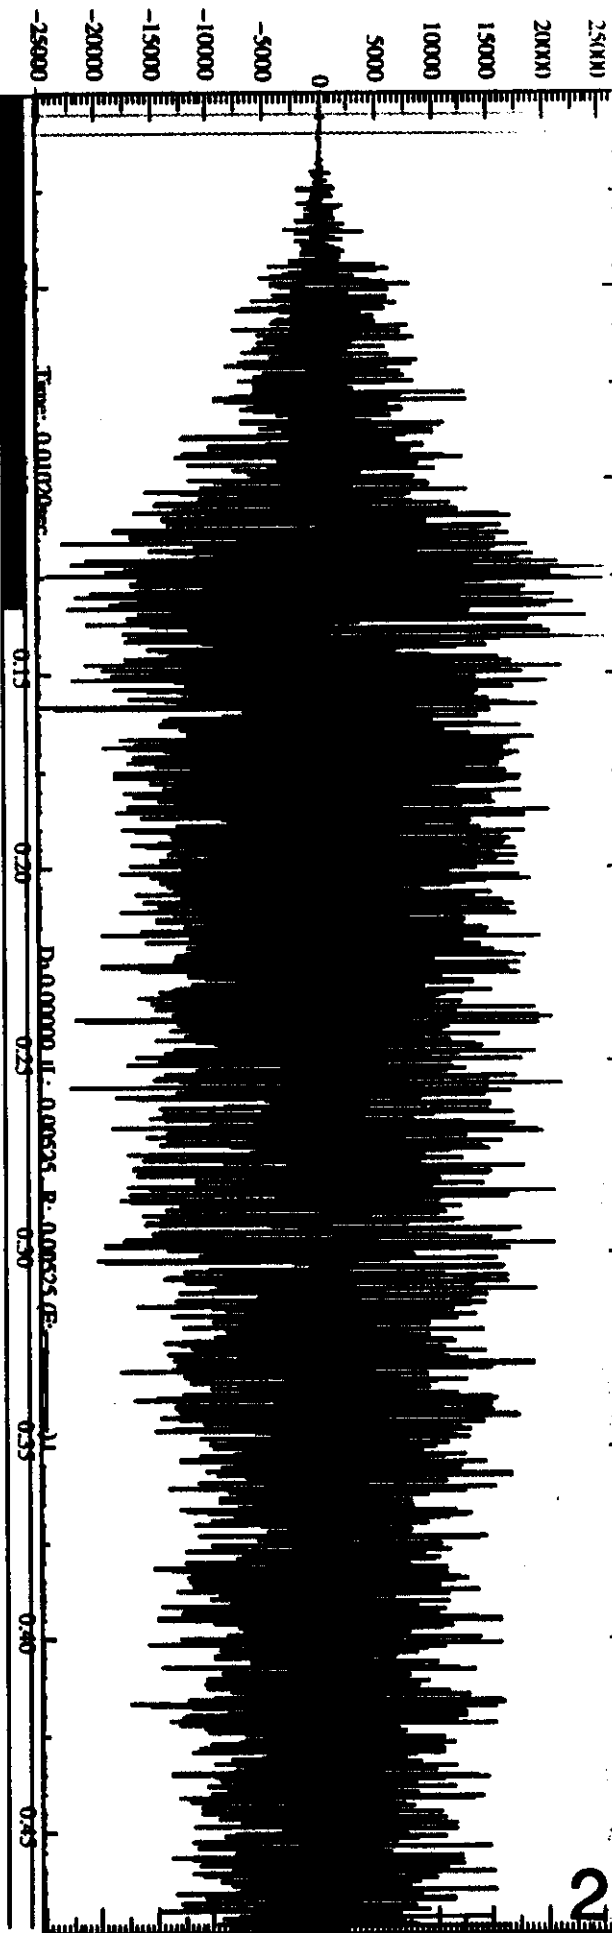
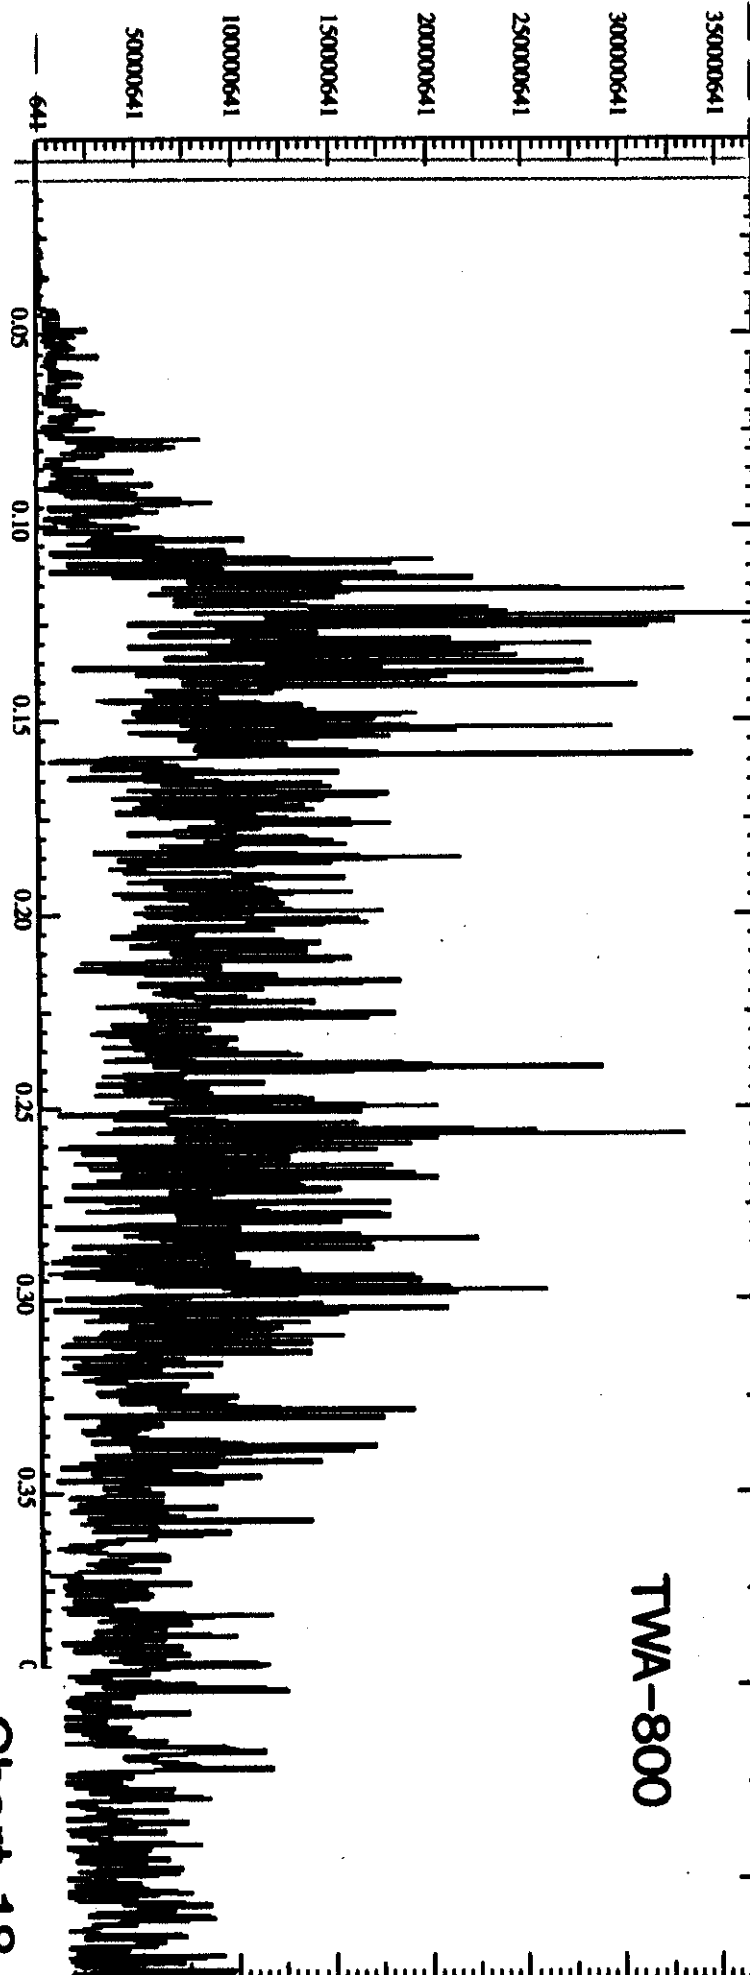
Chart 18

Charts 18,19,20,21, and 22 depict the area microphone channel and the associated energy or power distribution. These charts show the waveform of the area microphone channel on the top chart along with the energy on the bottom chart. The energy chart displays the total energy or power of the signal on the vertical axis and how it is distributed over time (horizontal axis).

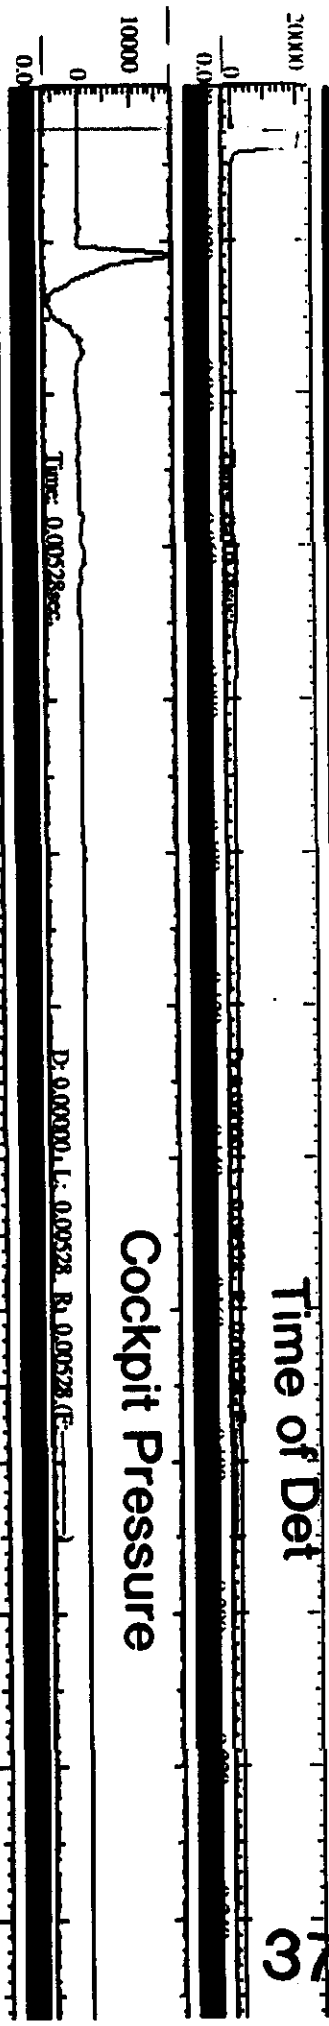
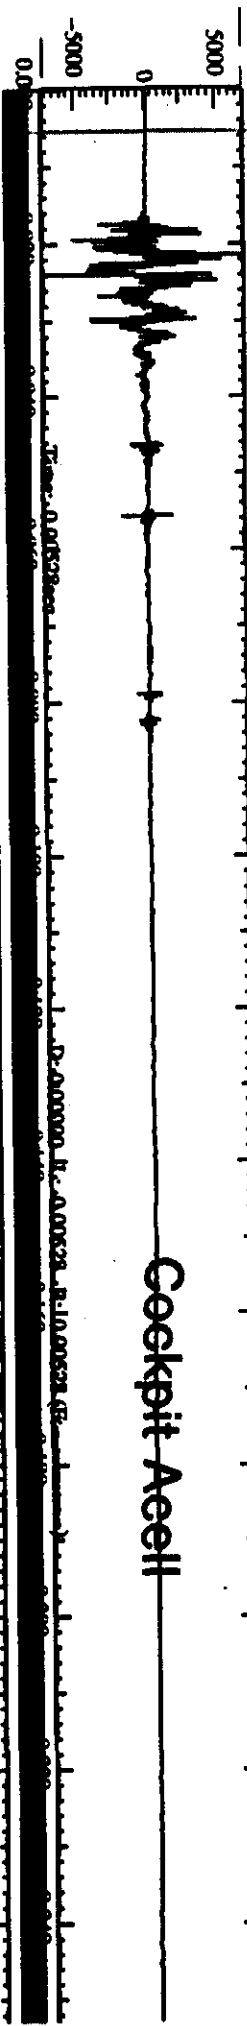
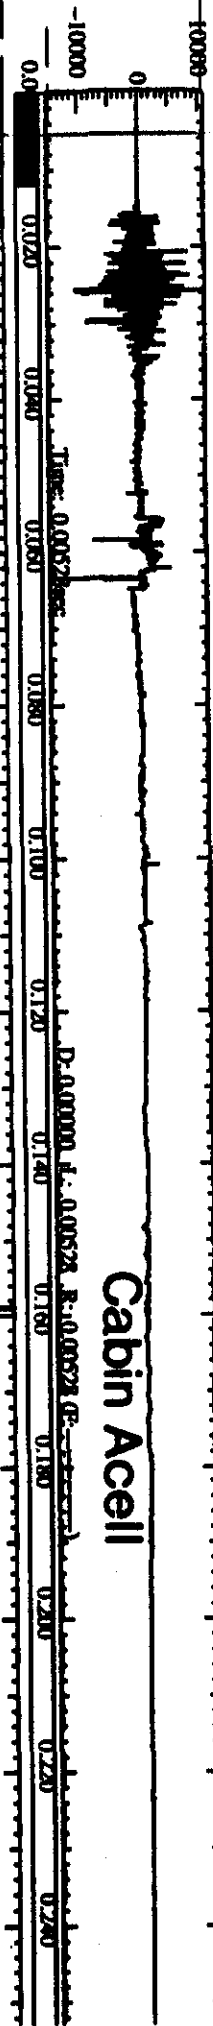
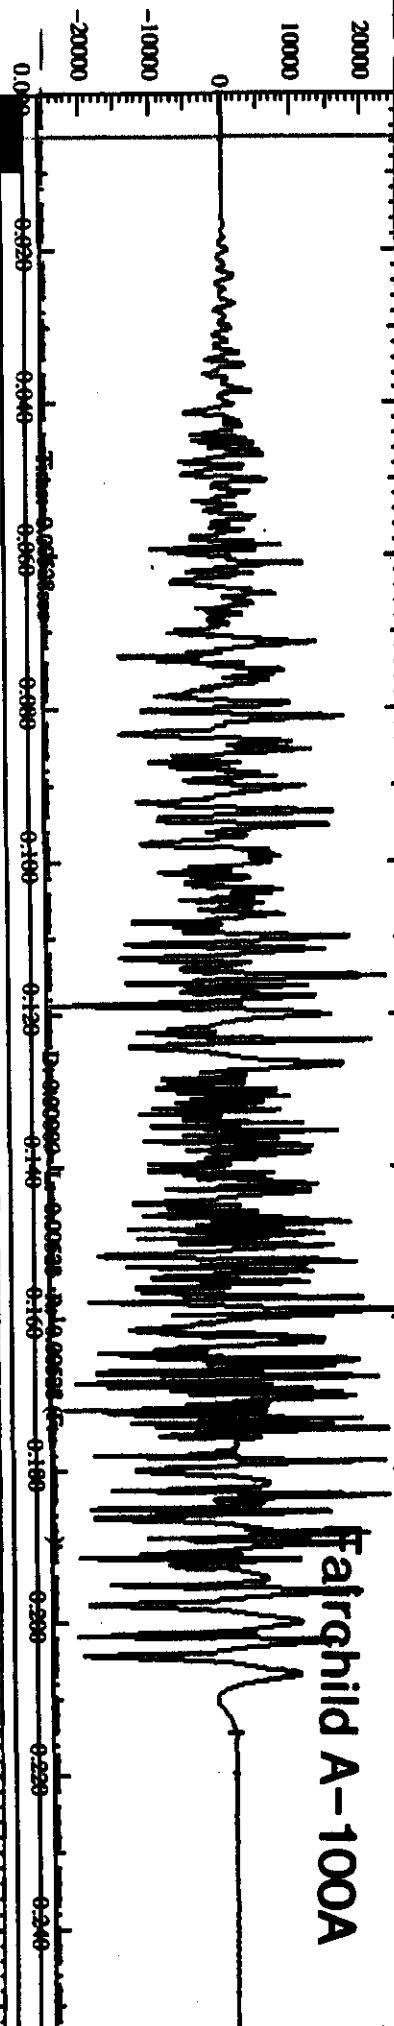
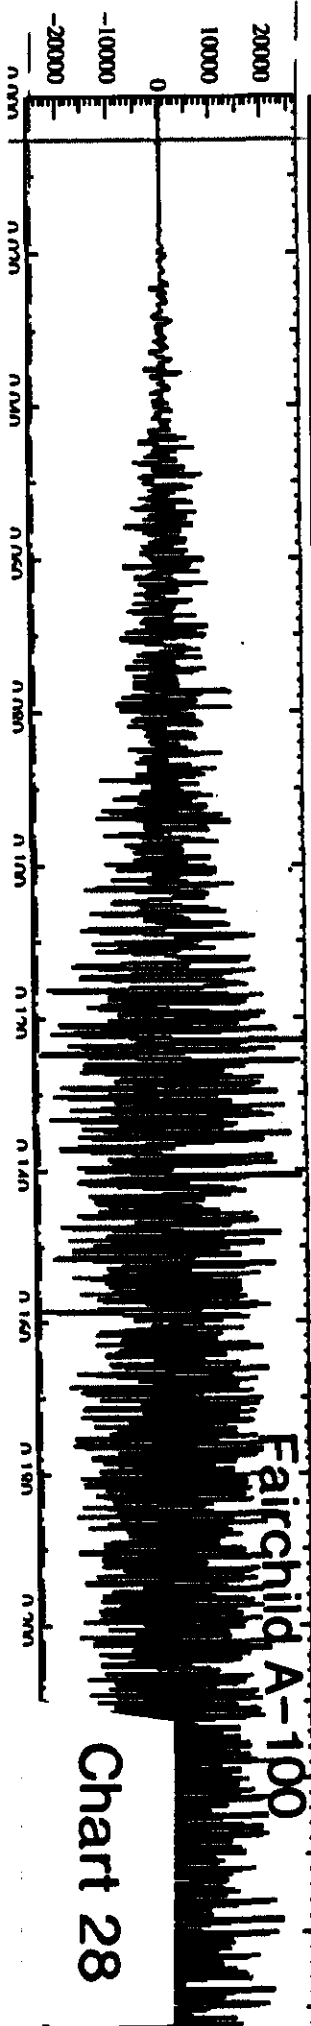
identical CVR systems and instrumentation as in the previous tests. Chart 26 depicts the data corresponding to a fuel-air test where the charge was located in the forward cabin directly below the cockpit (aircraft station 420). Chart 27 depicts the data obtained from a test where the charge was located in the mid-section of the aircraft over the fuselage center fuel tank (aircraft station 1380).

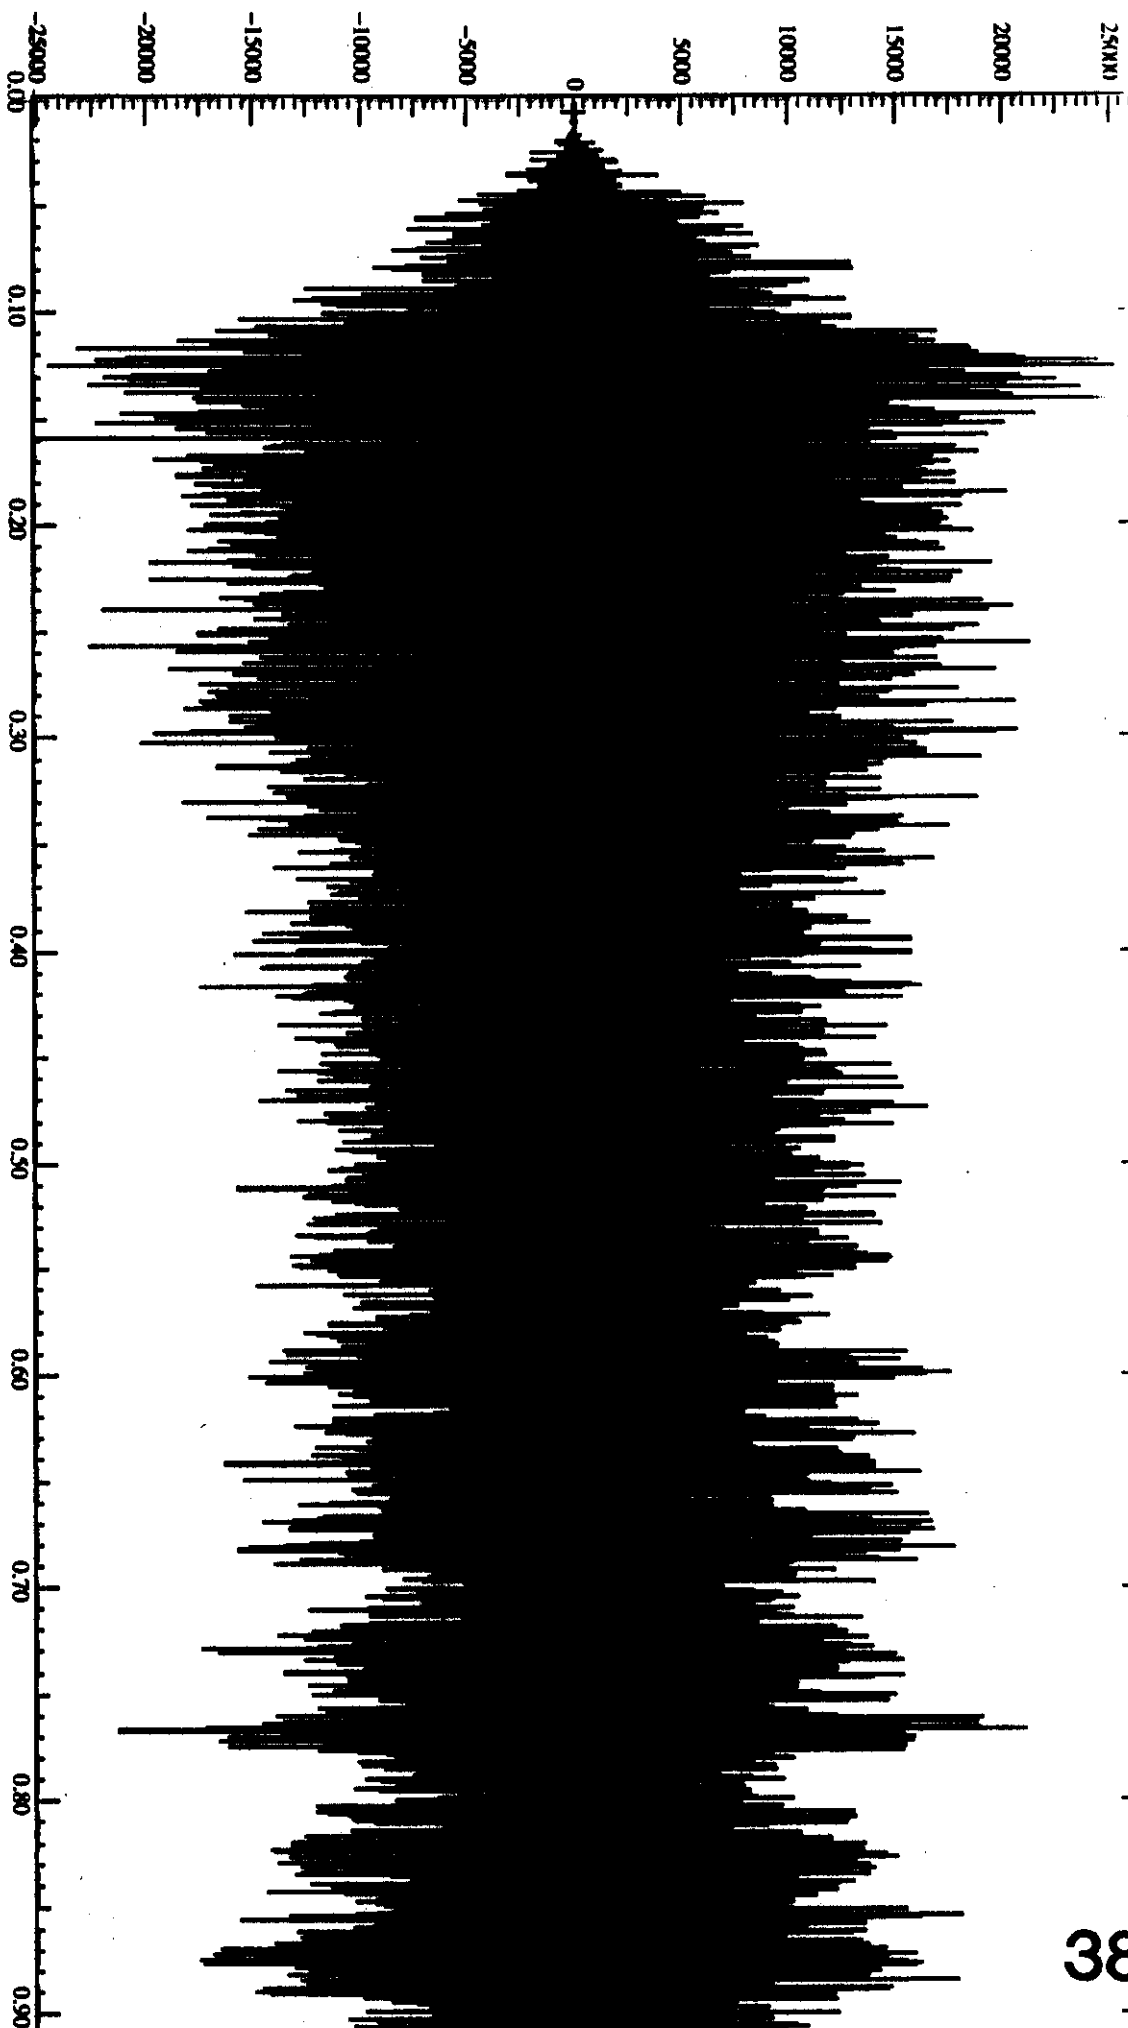
The final test in the trial was to explode a fuel-air mixture in the center wing fuel tank of the Boeing 747 aircraft. This test was conducted by injecting propane into the center wing tank to obtain a 3.2% propane/air mixture. The tank was ignited by placing a small high explosive device on the rear spar of the aircraft. The same CVR recorders and instrumentation were used to document the tank explosion. Chart 28 depicts the same 6 traces which represent the charge initiation (T_0), cockpit pressure, cockpit acceleration, cabin acceleration, Fairchild A-100A CVR, Fairchild A-100 CVR. Chart 29 depicts an expanded trace of the Fairchild A-100 CVR record and chart 30 depicts an expanded trace of the Fairchild A-100A CVR. Chart 31 depicts the sound data from the Fairchild A-100 CVR in addition to the power/energy distribution plot similar to what was shown on charts 18-22.
